## ADVANCED ANALYSIS OF BACKSHEET FAILURES FROM 26 POWER PLANTS

J. Markert, S. Kotterer, D. E. Mansour, D. Philipp, P. Gebhardt  
Fraunhofer Institute for Solar Energy Systems ISE  
Heidenhofstr. 2, 79110 Freiburg, Germany

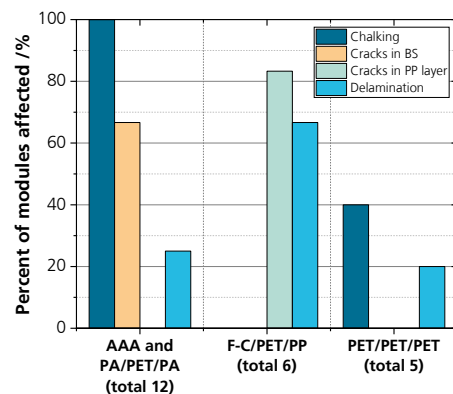
Polyamide backsheets were the most common types (reported from 12 sites) which were found during analysis and is certainly a known critical material [9]. Other critical material stacks were F-C/PET/PP (8 sites) and PET based structures (e.g. PET/PET/PET) (4 sites). Backsheets 1 – 3 from the table in Table 2 revealed to be the most relevant backsheets in terms of degradation and associated failure modes are shown and quantified in Figure 2. However, it is not clear to what degree these findings are representative for all backsheet products that contain these material combinations, because quality can range between different manufacturers and suppliers. It is merely an indication that at least some backsheets containing these materials showed critical degradation after field-exposure. Backsheet structures 4 - 11 listed in Table 2 were inconspicuous in terms of degradation and did not show visual evidence for an increased degradation level in the investigated cases. However, these materials were often found in the same module types that showed damaged backsheets as mentioned above.

**Figure 2:** Distribution of the failures in the most relevant degraded backsheet structures after several years of operation.

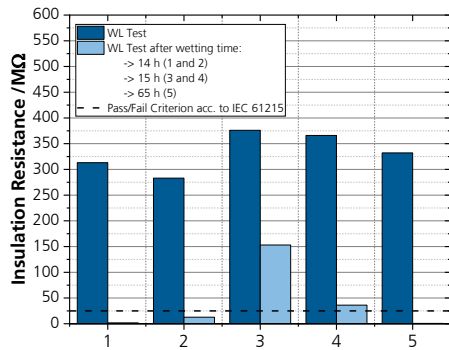
**Figure 3:** Wet leakage current test results of five exemplary modules from two power plants that have been measured initially and after extended wetting times: 15 h, 65 h and 14 h.

Five additional modules that passed the first WL test were subjected to an extended wetting time in a water bath for 14 h, 15 h and 65 h, respectively, before the WL test was applied for a second time. This was done in order to reproduce low insulation resistance values that had been observed in the field and had led to inverter outages. All five modules used the same backsheet foil: F-C/PET/PP. The measurements showed a strong decrease of the insulation resistance values in the modules after the extended wetting time (Figure 3), which coincides well with the observed inverter outages. This suggests that an increased wetting time beyond the test conditions according to IEC 61215-2:2016 (MQT 15) can be required to detect low insulation properties that lead to inverter outages.

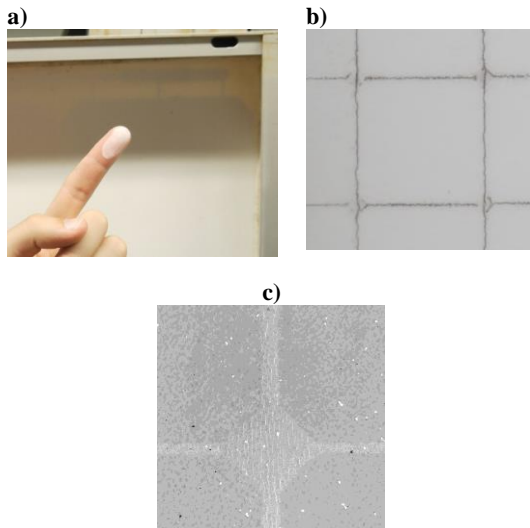
**Figure 4:** Images from different degradation features; a) Chalking on rear side of a polyamide backsheet [10]; b) Cracked AAA backsheet; c) Small cracks, indicating a damaged PP layer in a F-C/PET/PP backsheet.

All modules with polyamide backsheets (AAA and PA/PET/PA) as well as 40 % of the PET based backsheets deposited a white powder (Figure 4 (a)), known as chalking [10], on the rear surface after field exposure. 67 % of the investigated backsheets with polyamide developed cracks Figure 4 (b), typically in the cell gaps, suggesting a degradation mechanism initiated by front side UV radiation [3], or along the cell connectors, indicating the appearance of thermo-mechanical stresses in these regions. The PET based foils, on the other hand, showed no visual defects besides chalking and insulation issues have reported from one module only. This suggests that there might be a connection between chalking and the formation of backsheet cracks in polyamide layer structures. Furthermore, it has been demonstrated that, moisture inside the polymer plays a synergistic role with UV in the formation of backsheet cracking [11][12]. Backsheet chalking can therefore be evaluated as an early warning sign that indicates an elevated probability for the

presence of a critical material and possible crack development in the future.

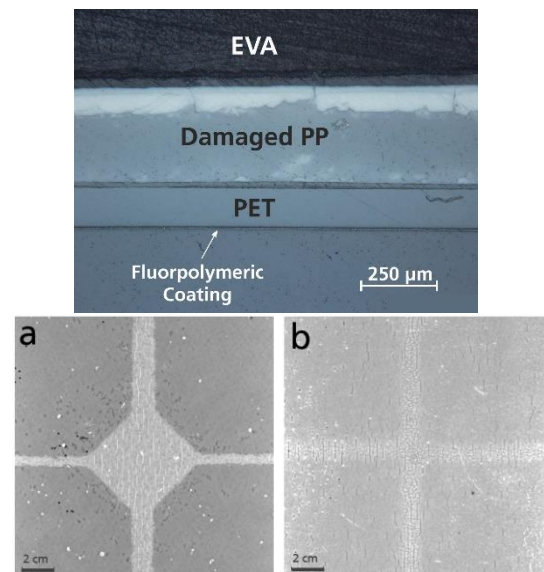
Hidden damages in the inner PP layer were found in F-C/PET/PP structures, despite a regular outer appearance of the backsheet. Cross-sectional images (Figure 6, left) revealed severe damage in the cell gaps within the backsheet in more than 80 % of the investigated modules with this backsheet type. The location between the cell gaps indicates one more time a degradation mechanism due to UV radiation. Illumination of the modules from the front side, sometimes referred to as “flashlight test” was found to be a straightforward and cheap method to identify affected modules. This can be done with a flashlight, shining through the backsheet in the cell gaps. On the rear side, the shadows of the tiny cracks in the PP layer become visible, similar to the image taken of an affected backsheet with a scanning acoustic microscope in Figure 4 (c). This method can serve as a first indication of cracks inside the layer structure. A clear disadvantage of this method is that only the cell gaps can be analyzed and cracks along the busbars remain undetected.

As another analysis technique, scanning acoustic microscopy was used to uncover backsheet cracking in specific layers non-destructively [11]. Figure 6 right (a and b) presents acoustic micrographs obtained from different time of flight (TOF) ranges inside the multilayered backsheets.

**Figure 6:** Top: Cross section of a F-C/PET/PP coating with damaged PP layer. Bottom: Acoustic images of the multilayer backsheets in a field-exposed PV module; (a) core/inner layers interface of F-C/PET/PP backsheet; (b) outer/core layers interface of PA/PET/PA backsheet.

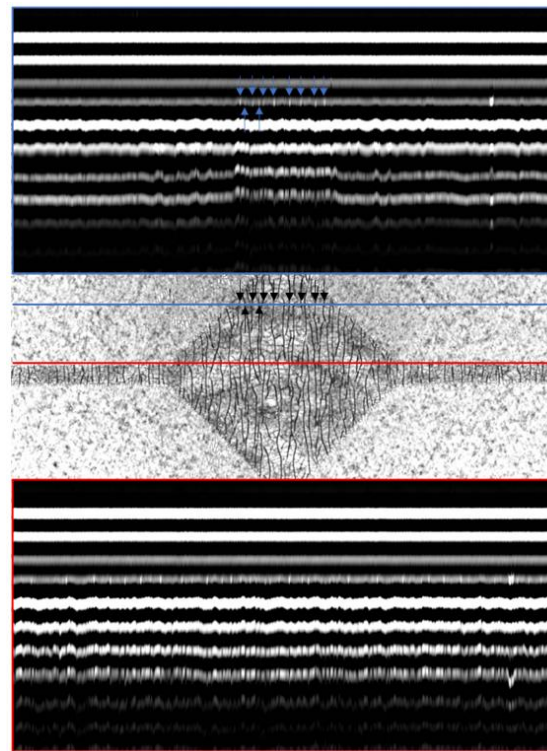
**Figure 7:** Acoustic cross-sections of a module with F-C/PET/PP backsheet revealing internal cracks (top and bottom), taken at the lines indicated in the micrograph (middle).

In order to validate the visualization of the location of these cracks and the depth profile of the PV module, acoustic line-scans along two different positions were executed, as presented in Figure 7 for a module with F-C/PET/PP backsheet and in Figure 8 for the module with APA backsheet. The corresponding backsheet cracks in the upper lines are marked with arrows for the comparison

The acoustic cross-sections confirm the same crack positions within the layer stack of the different modules. For modules with F-C/PET/PP backsheet, the cracks are visible at the 4<sup>th</sup> interface starting from the top line, which means at the backsheet inner/EVA layer interface. This coincides well with the results of optical microscopy (destructive) of the same material (Figure 6, left). For the module with APA backsheet, the cracks appear slightly earlier at the 2<sup>nd</sup> interface, i.e. the outer PA/core PET layer interface. This coincides well with the results of optical microscopy (destructive) of the same material (Figure 5, left), whereas, for the module with APA backsheet, the cracks appear slightly earlier at the 2<sup>nd</sup> interface, i.e. the outer PA/core PET layers interface.

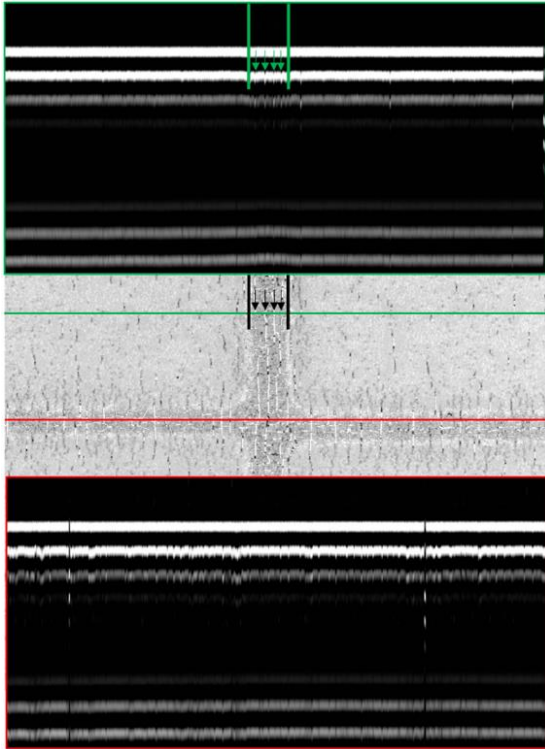
**Figure 8:** Acoustic cross-sections of a module with PA/PET/PA backsheet with polyamide outer layer cracking (top and bottom), taken at the lines indicated in the micrograph (middle).
