## ADVANCED ANALYSIS OF BACKSHEET FAILURES FROM 26 POWER PLANTS

J. Markert, S. Kotterer, D. E. Mansour, D. Philipp, P. Gebhardt  
Fraunhofer Institute for Solar Energy Systems ISE  
Heidenhofstr. 2, 79110 Freiburg, Germany

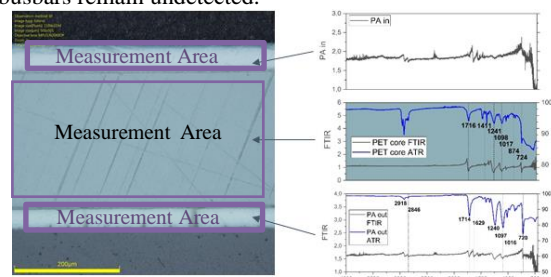
**Figure 5:** Left: Microscopy image of the multilayer PA/PET/PA backsheet cross-section in a PV module. Right: Comparison of FTIR microscopy spectra (black) of cross-section samples and ATR-FTIR

spectroscopy spectra (blue) of separated backsheet surface layers.

The PET layer, which can be found in the core of the backsheet in the left image of Figure 5, is shown in a comparison of the FTIR-ATR spectrum with the FTIR-microscope spectrum. As indicated by the vertical markers, all significant peaks of the FTIR-ATR spectrum can also be observed in the FTIR spectrum of the PET layer.
